St. Marys River
Shoreline Erosion and Shore Structure Damage
1980 Closed Navigation Season

February 1981

Corps of Engineers
U.S. Army Cold Regions Research and Engineering Laboratory
Hanover, New Hampshire 03755

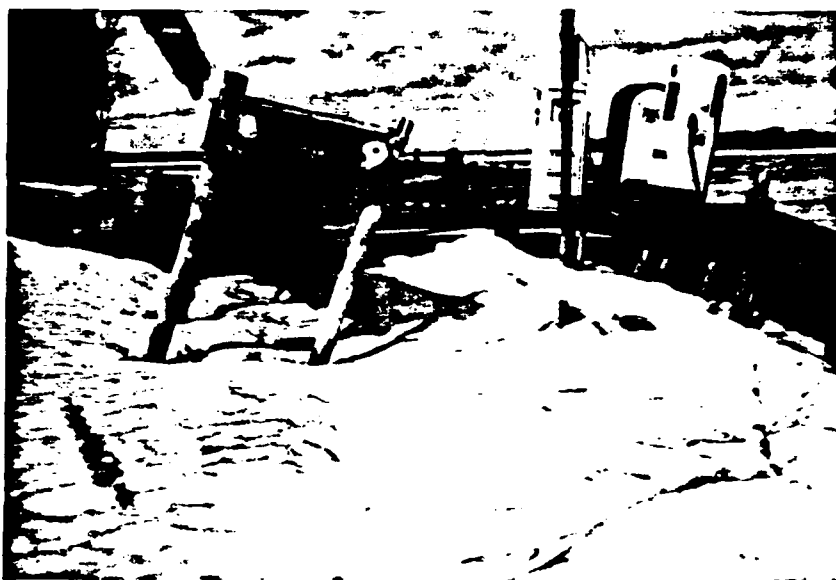
Figure 14. Dock pulled offshore due to horizontal ice movement.

the channel. The following rise in water levels does not completely close the crack, and there can be some freezing of new ice in the crack. With repeated cycles, this mechanism can incrementally jack the ice cover horizontally toward the channel. If any cracks pass through a structure they can be pulled offshore as well as shown in Figure 14. This has occurred so

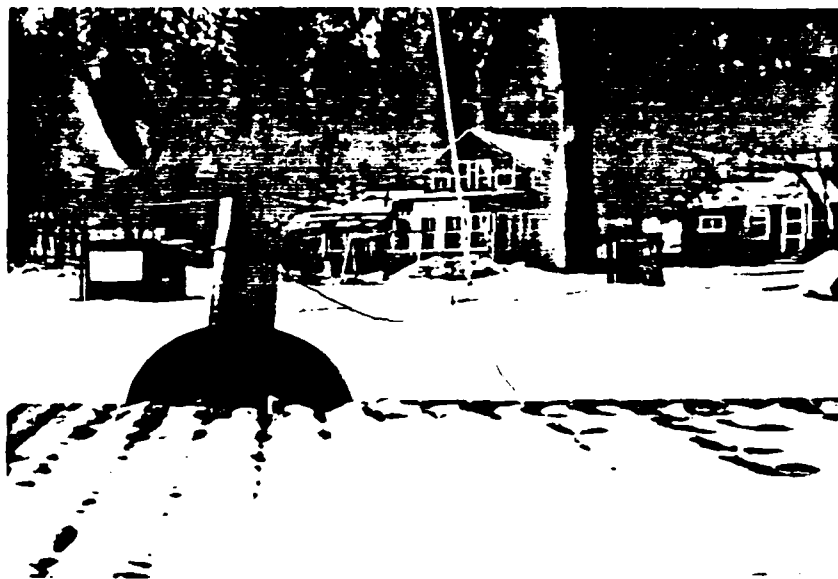
Figure 15. Dock attached to shore by cable to reduce movement.

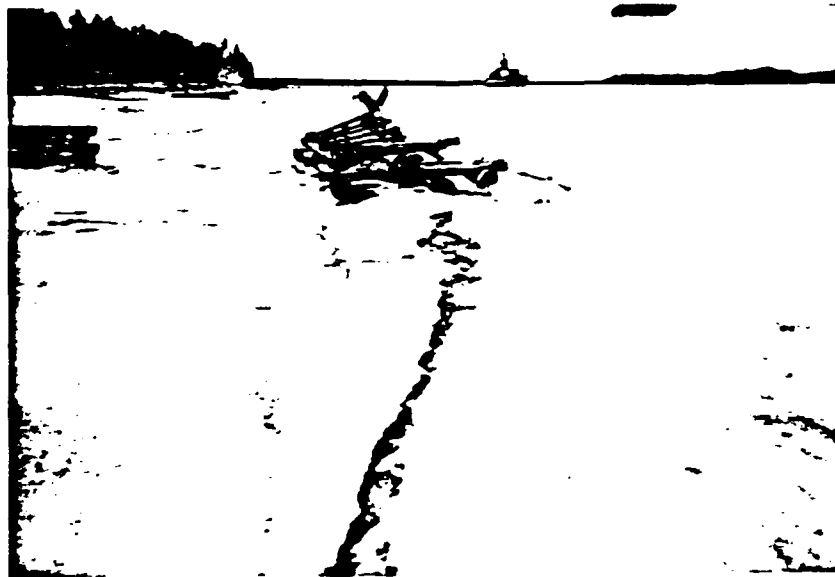
Figure 21. Active crack passing through dock.

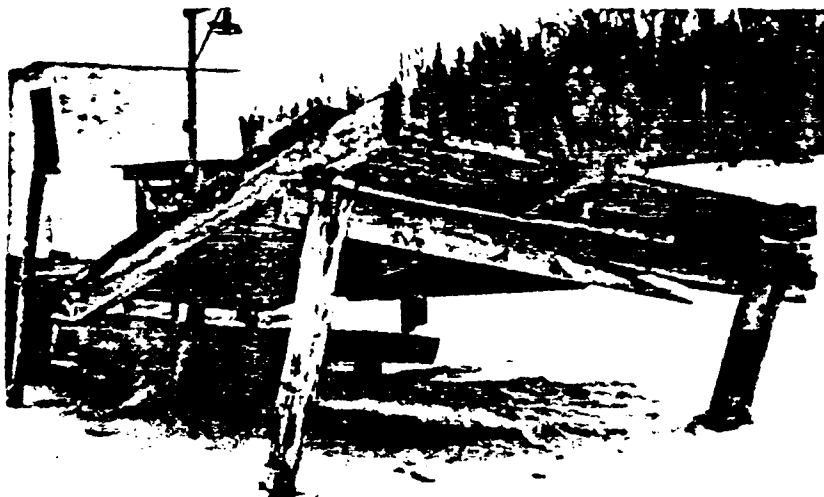
Figure 45. Franklin Resort dock, end view.

Figure 46. Franklin Resort dock, side view.

dock structure suffered significant damage due to uplifting forces as shown in Figures 45 and 46 taken during the 1976-1977 winter season.

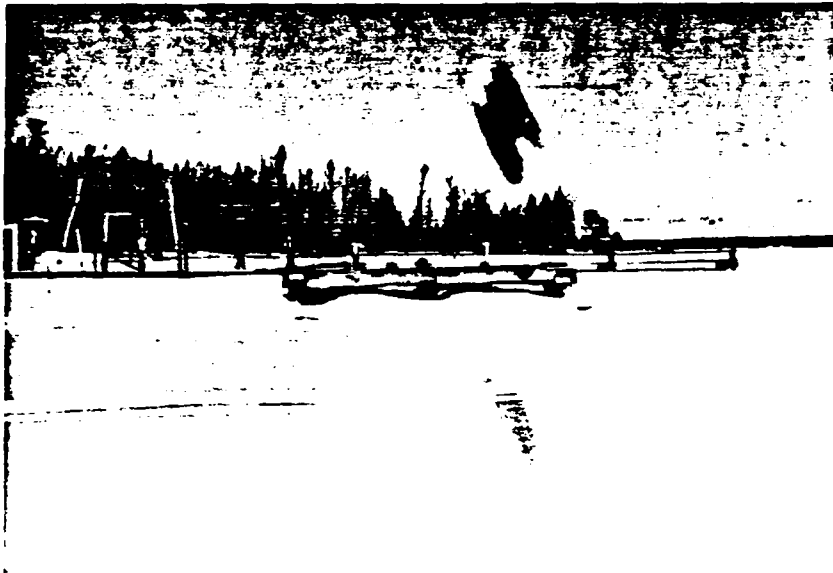
Figure 47. Dark Hole timber crib.

very well during both winters they were in place. The original Franklin Resort dock which can be seen on the left side of Figure 47 (9 February 1980) experienced no perceptible damage during the winter season.

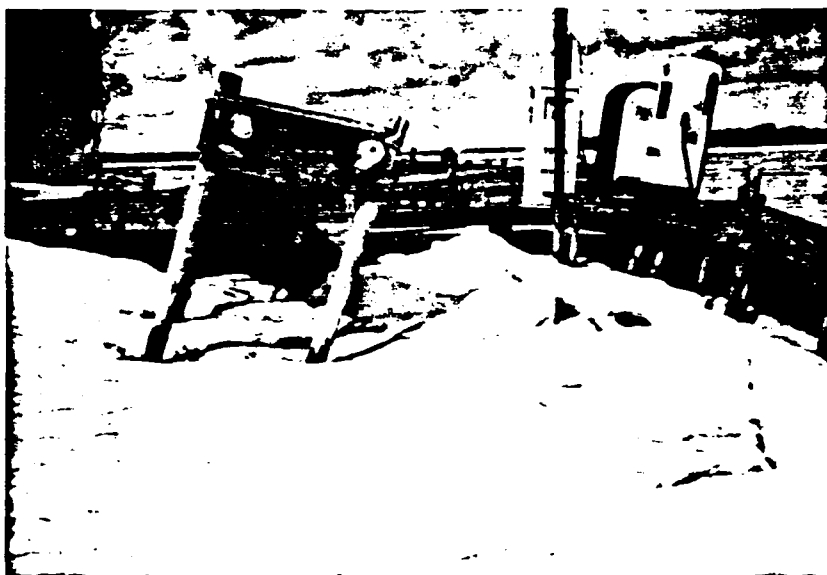
Figure 51. Spreading of finger piers by ice action.

from the 1977 navigation season and shows a large shore-parallel active crack passing just offshore of the structure. Other cracks passed through the structure resulting in the spreading of the finger piers shown in Figure 50 and 51.

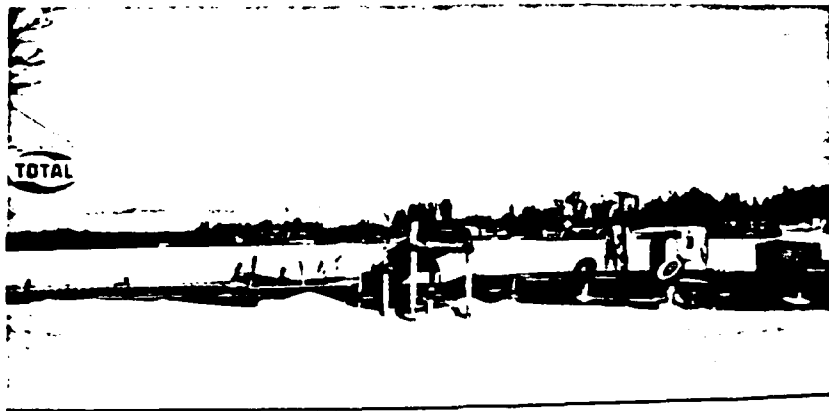
During last year's closed navigation season these cracks were not evident. Figure 52 shows conditions several weeks after the close of navigation. No active cracks were evident. The uplifted docks shown in Figure

Figure 52. Little Neebish Resort at beginning of closed navigation season.

52 were in that condition at the close of navigation and no further change was observed during the closed period. Figure 53 taken on 30 March again shows the uplifted finger pier with no further perceptible damage.

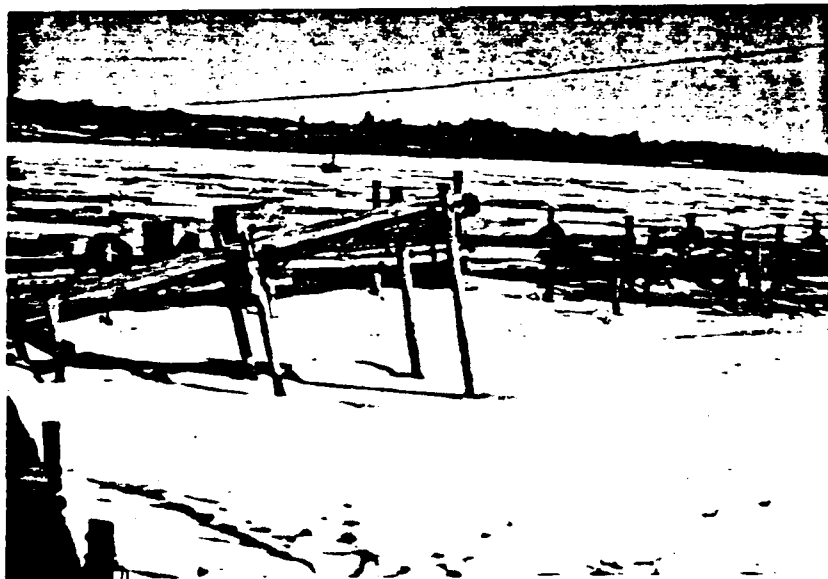
Figure 53. Little Neebish Resort with navigation reopened.

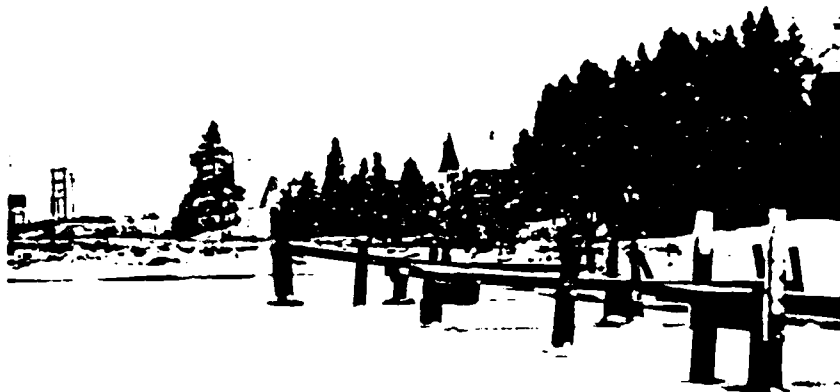
Detour. Figures 56 and 57 show the condition of a series of small docks near the mainland Drummond Island Ferry dock on 25 January 1980. Some uplift is apparent, but as shown in Figures 58 and 59 taken on 15

Figure 56. Small docks at Detour after close of navigation.

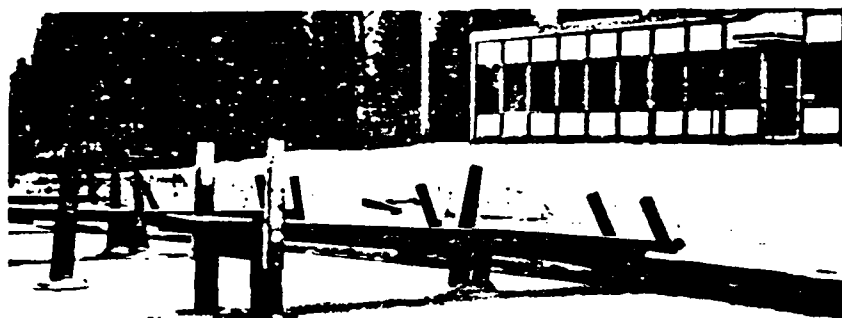
Figure 57. Small dock at Detour after close of navigation.
